CASE REPORT

Migration of etonogestrel contraceptive implants: Implications for difficult removals services need in southern Africa

S Afr Med J 2019;109(8):559-561. DOI:10.7196/SAMJ.2019.v109i8.14061

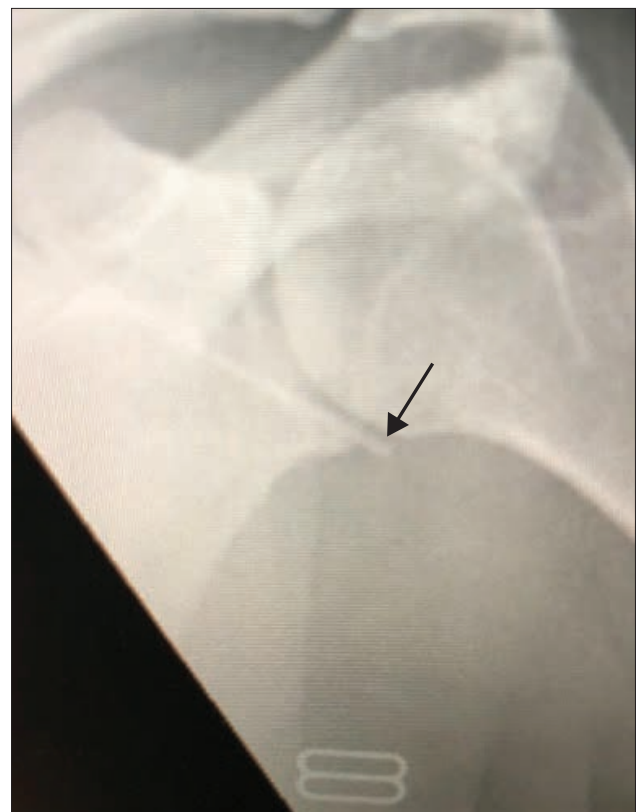
Fig. 1. Case 1. Radiograph of left upper arm demonstrating implant location above the glenohumeral joint, in the deltopectoral groove (arrow indicates tip of implant).

The radiograph revealed a linear foreign body just above the glenohumeral joint in the area of the deltopectoral groove (Fig. 1). The image was compatible with a radio-opaque ENG implant. Surgical removal of the implant under general anaesthesia was performed on the same day by two of the authors. The patient was

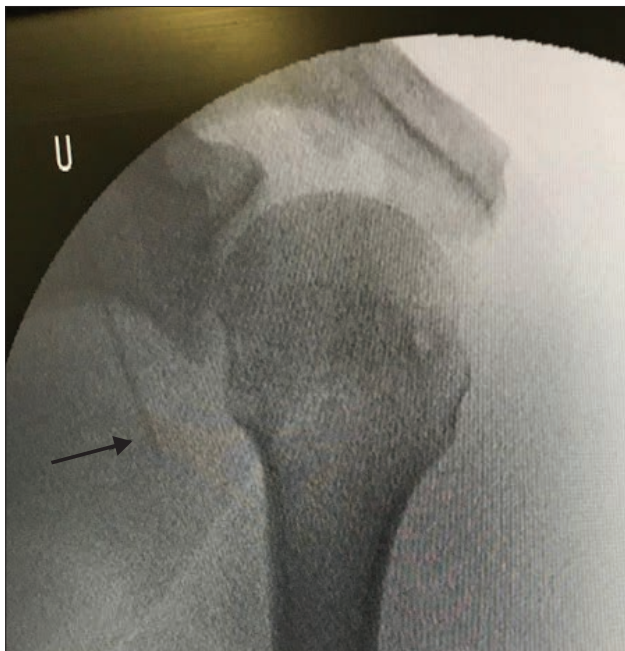
Fig. 2. Case 1. Intraoperative radiograph showing an etonogestrel implant lying anterior to the left shoulder (arrow indicates tip of implant).

cleaned and draped in the beach-chair position, and given 2 g of intravenous cefazolin preoperatively. An X-ray unit with a C-arm was used intraoperatively to locate the implant (lying anterior to the left shoulder) and guide incision (Fig. 2). A 6 cm incision was made over the deltopectoral groove, directly over the implant; the implant was located with blunt dissection and was found superficially in the deltopectoral groove. Careful dissection revealed that it was within the cephalic vein. The vein, which was sclerosed around the implant, was mobilised and ligated proximal and distal to the implant. The implant was then removed (Fig. 3). The minimal intraoperative bleeding was controlled with electrocautery. The wound was washed and closed with Vicryl 2/0 and subcutaneous Monocryl 3/0 sutures, and dressed in sterile fashion. Postoperatively, the patient was mobilised without restriction. We suspect lateral and deep (not subdermal) insertion into the cephalic vein as the mechanism of migration.

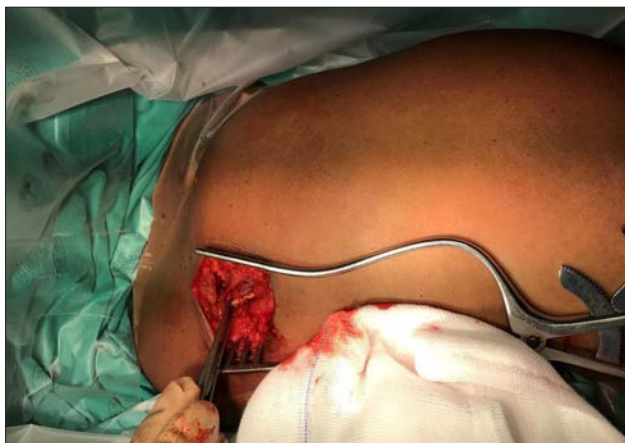
Fig. 3. A 6 cm incision through which an etonogestrel implant was found and removed from the deltopectoral groove within the cephalic vein.

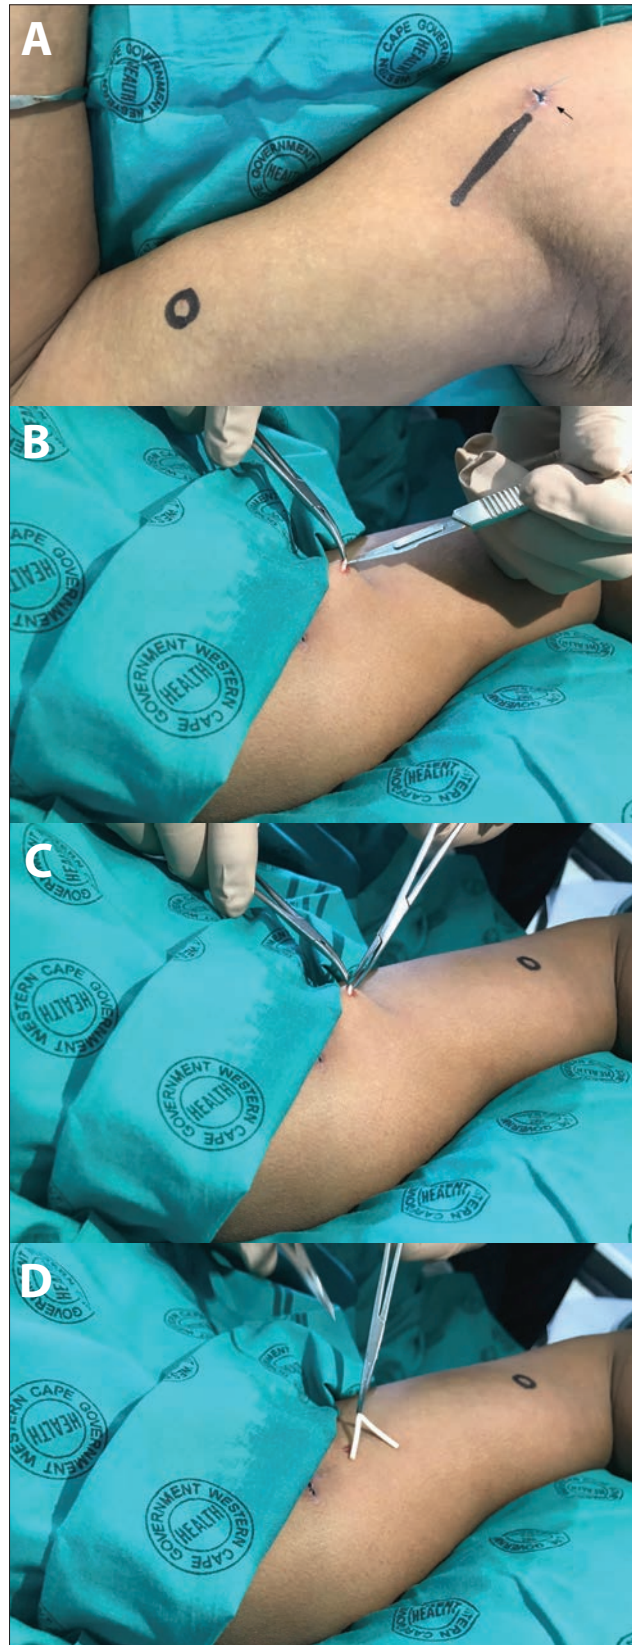
Fig. 4. Case 2. Location and removal of an etonogestrel implant that superficially migrated to the anterior glenohumeral joint. In panel A, the small arrow points to the healing incision through which a general practitioner had attempted removal, the circle marks the original insertion site, and the line indicates location of the implant identified via ultrasound at the referral clinic. B - D show removal of the implant by grasping its midpoint with modified vasectomy clamps and pulling it up through a small incision.

migrated ENG implant. The implant had been inserted 6 months previously at a community clinic. The patient wanted it removed because of the notable migration from the place of insertion. She reported that it had moved to her right shoulder region gradually, over time. On examination, there was a clear skin marking showing the original insertion site (Fig. 4 A, area marked with circle on skin), which was situated over the short head of the biceps muscle on the right upper arm. The SA National Department of Health's 2014 training recommendation was for ENG implant insertion over the head of the biceps muscle, in the non-dominant arm (South African Training of Trainers Session on Insertions and Removals of Contraceptive Implants, February 2014, Cape Town, SA – unpublished; and as described in Guillebaud⁽⁴⁾). The implant was easily palpable over the glenohumeral joint, and removal had therefore been attempted in the community clinic by the general practitioner, without imaging. However, the attempt had failed, and the patient was referred. At the difficult removals clinic, the location was confirmed via ultrasound and marked with a line (Fig. 4 A, linear marking). A local anaesthetic, Xylotox 1.8 ml, was given over the middle of the implant. A small skin incision was made with a No. 11 blade. The implant was grasped with a modified vasectomy clamp at the midpoint of the implant, and elevated to the surface of the skin (Fig. 4, B and C). The capsule was incised and the implant was easily removed (Fig. 4 D). No skin sutures were required, and the incision was closed with SteriStrips and an Opsite Transparent Adhesive Film Dressing. Although the insertion site and depth were correct according to SA guidance at the time and the implant had been palpable ever since insertion, the patient had lost a significant amount of weight (8.5 kg in 6 months). We hypothesise that weight loss had propagated migration of the implant along the tissue plane of the biceps muscle.
